# Manhole Inspection Summary

Manhole # S31M\_\_011MH

Insp Date: **12/26/08 10:19 AM**

**Location** Address: **652 W Conway St**

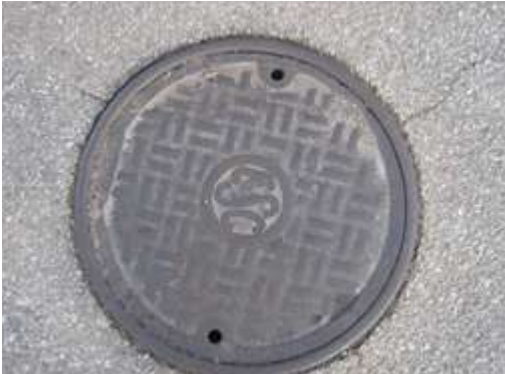
Misc

cover

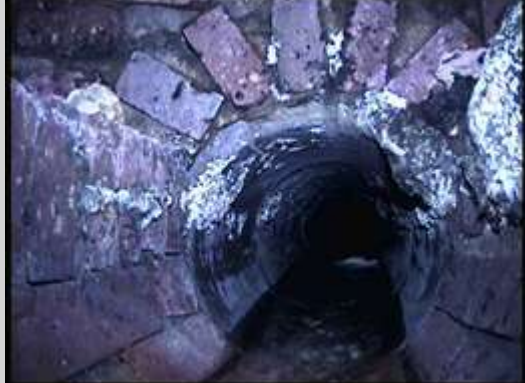
12 O'Clock Outflow

10 in. Circular Gravity Sewer  
Pipe Out @ 12 O'Clock

Pipe Height: **9.6** (in.) Rod and Bar (Angled)  
Pipe Material: **Clay** ☐ Pipe Lined  
Invert Depth: **12.40** (ft.) Flow Characteristics: **Fast**  
Deposits: ☒ None ☐ Mud ☐ Sludge ☐ Debris ☐ Grease  
Silt Depth: **0** (in.) Deposits Extent:  
Infiltration: **None** Pipe Seal Cond: **Sound**

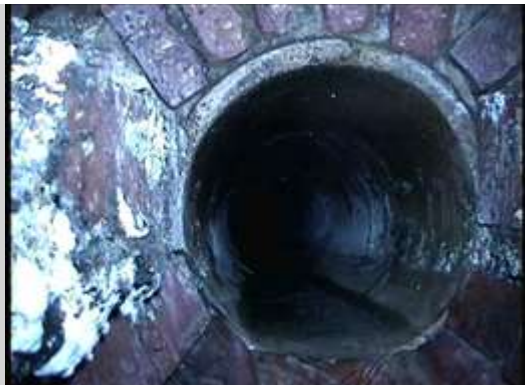
3 O'Clock Inflow

10 in. Circular Gravity Sewer  
Pipe In @ 3 O'Clock

Pipe Height: **10.8** (in.) Rod and Bar (Angled)  
Pipe Material: **Clay** ☐ Pipe Lined  
Invert Depth: **12.08** (ft.) Flow Characteristics: **Fast**  
Deposits: ☒ None ☐ Mud ☐ Sludge ☐ Debris ☐ Grease  
Silt Depth: **0** (in.) Deposits Extent:  
Infiltration: **None** Pipe Seal Cond: **Sound**
